Report 2433

2
**TEST REPORT
for the
EVALUATION
of the
PIPELINE OUTFIT, PETROLEUM (POP)**

**Prepared by the
FUELS HANDLING R&D TEAM
BELVOIR RD&E CENTER**

5 May 1986

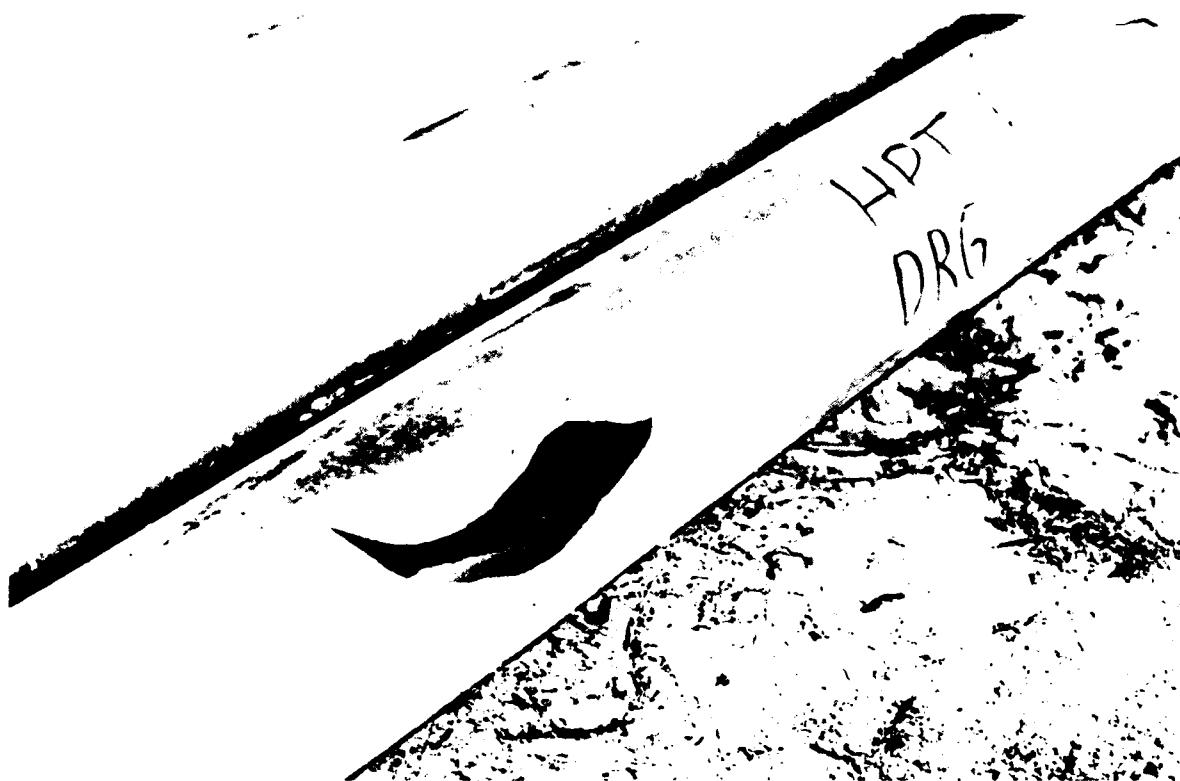
Photo #5: Hydrostatic pressure test #6. Pipe wall burst at 1,980 psi with coupling 5 failure.

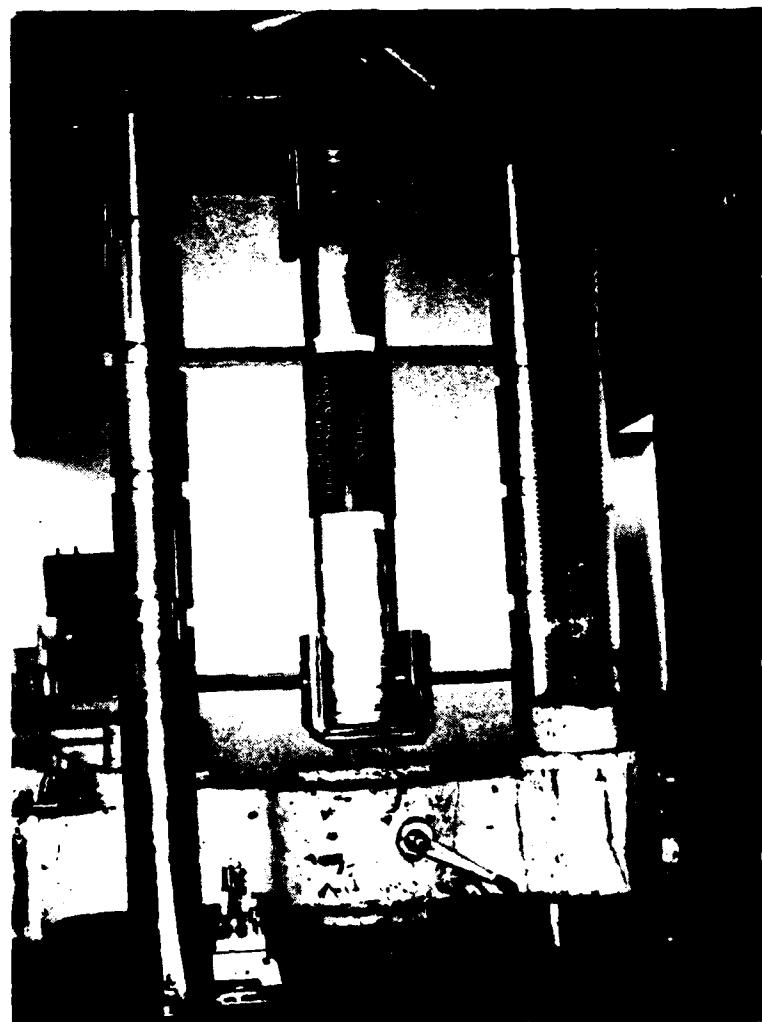
Photo#8: Lab tensile test sample mounted in the Baldwin tensile test machine.

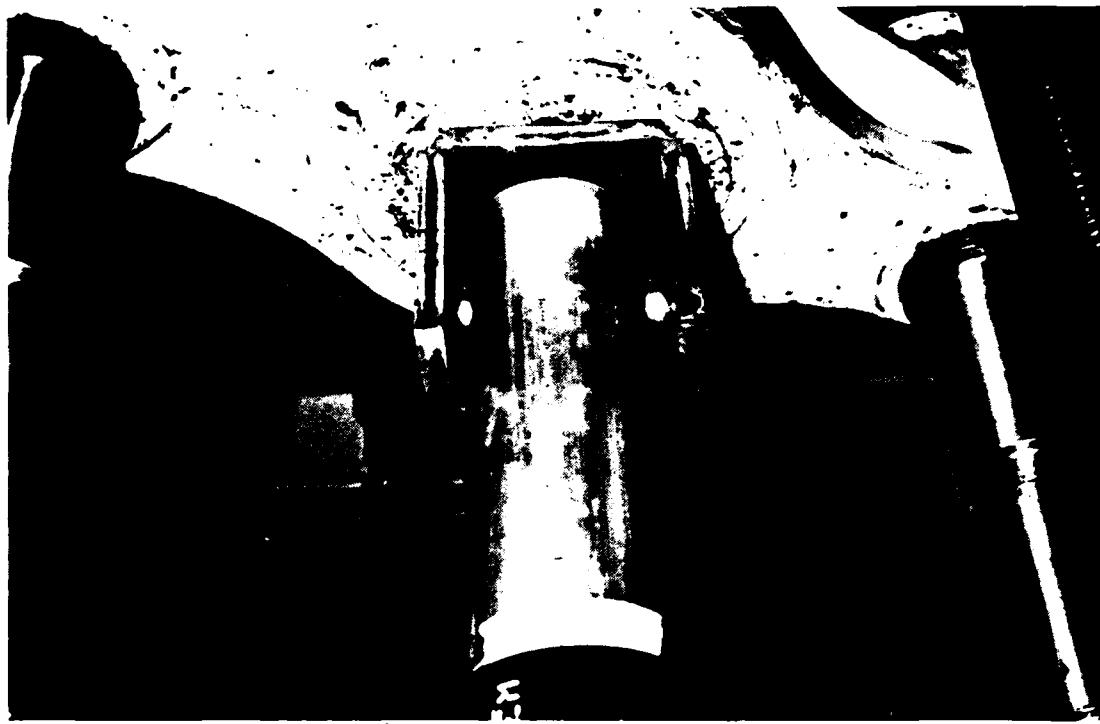
Photo #9: Pipe wall deformation at 28,000 lb of tensile stress Test #4.

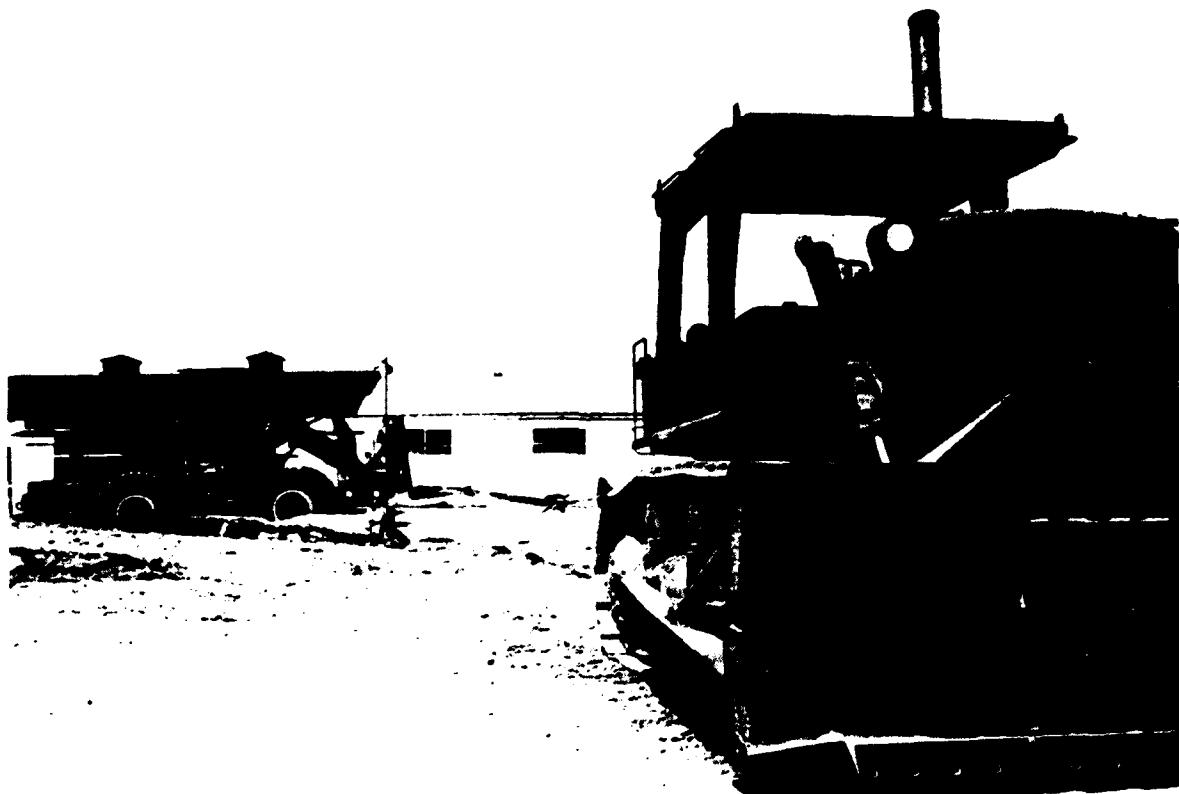
Photo #11: Field tensile test showing setup and bending of the samples.

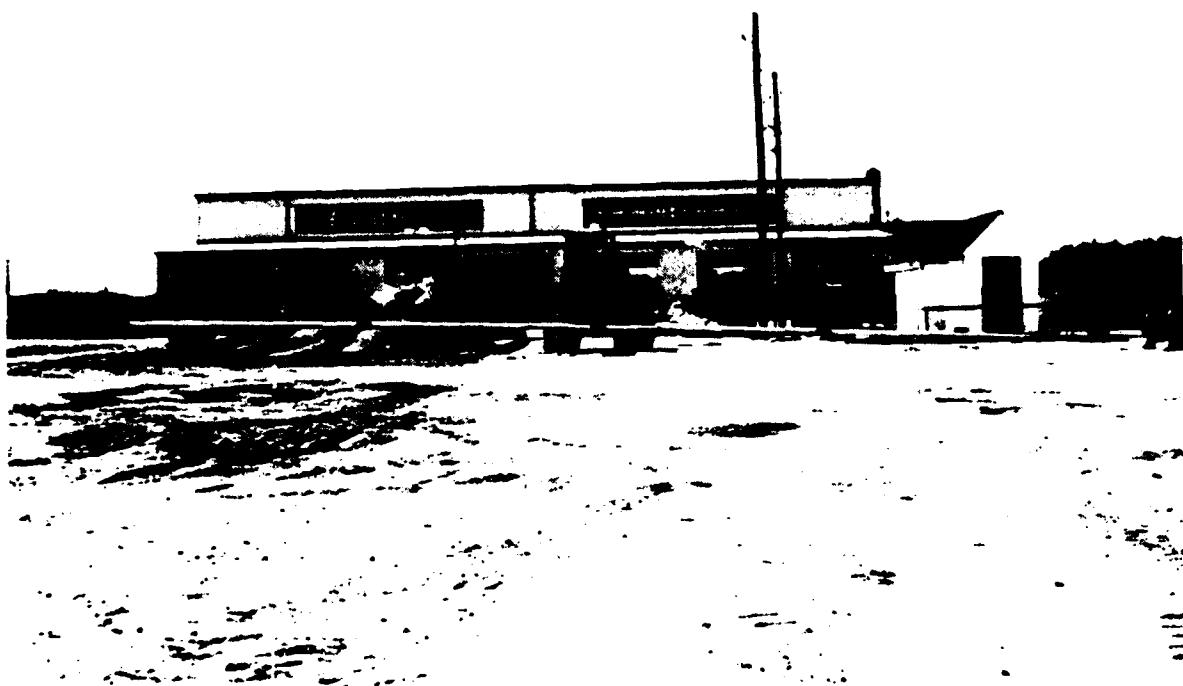
Photo#12: Field tensile test setup.

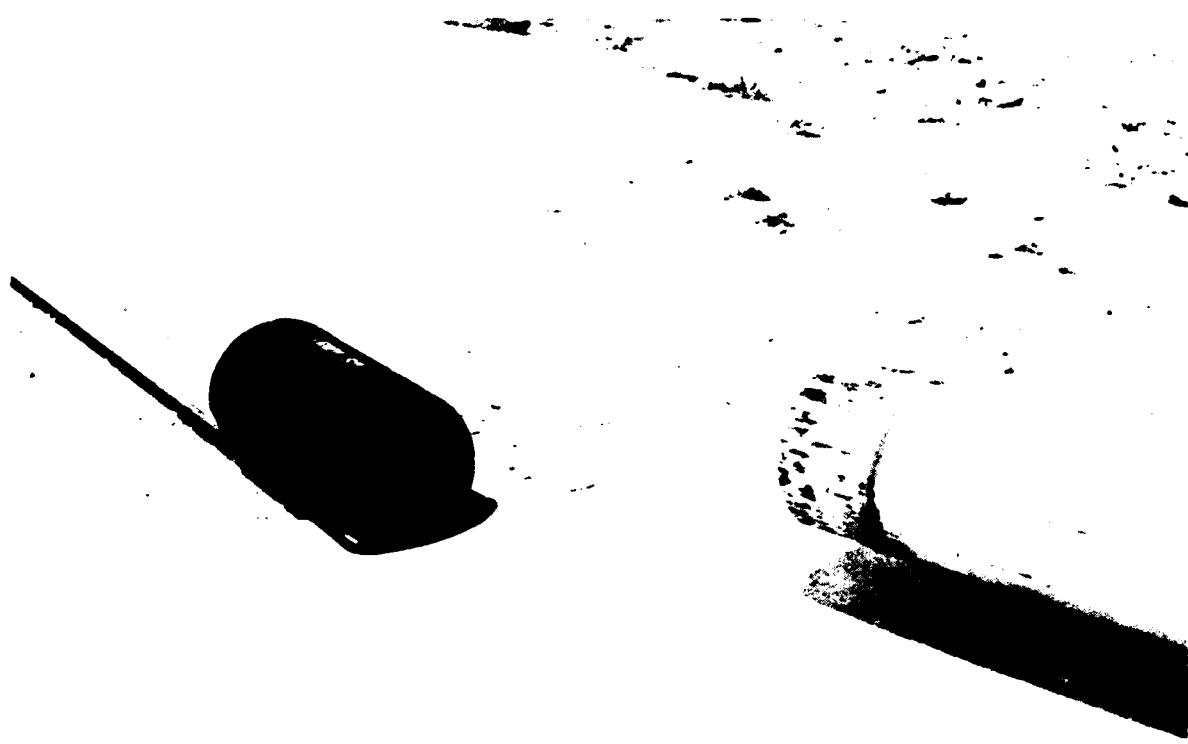
Photo #15: Field tensile test #2. Plain end aluminum pipe. Pull out at less than 52,000 lb

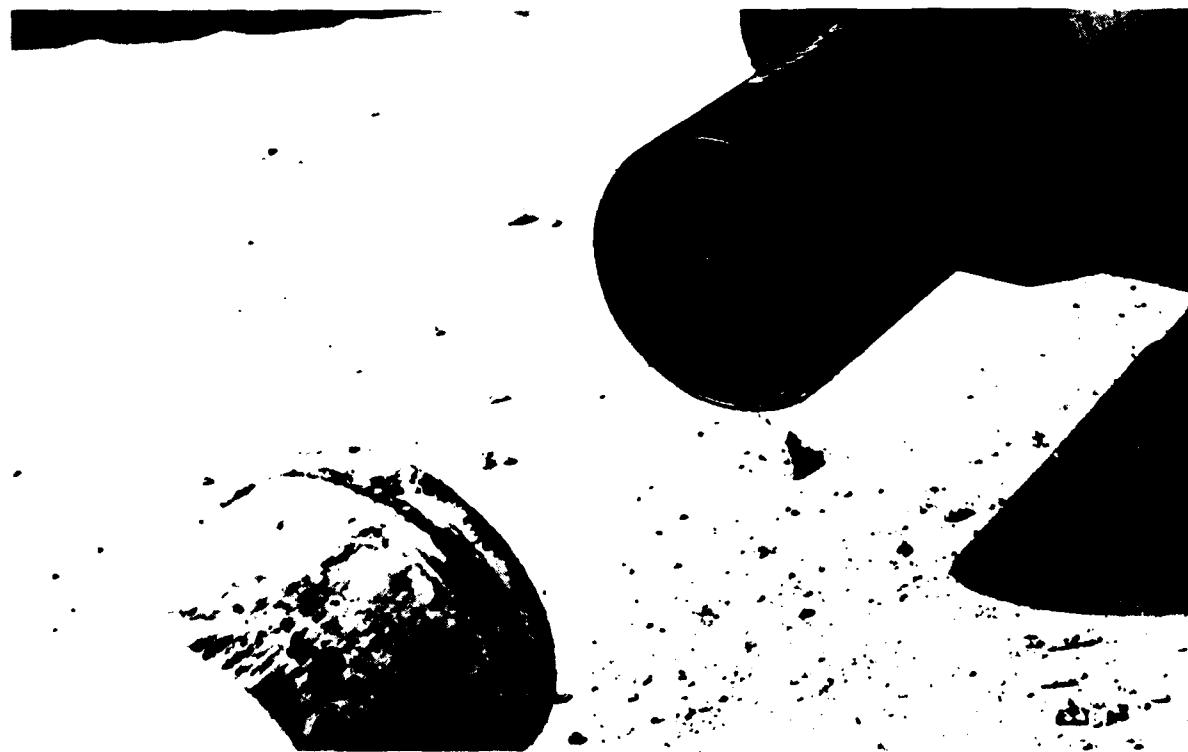
Photo#16: Field tensile test#3. Double-rolled-groove ends. Pull out at less than 40,000 lb.failure at 2,000 psi.

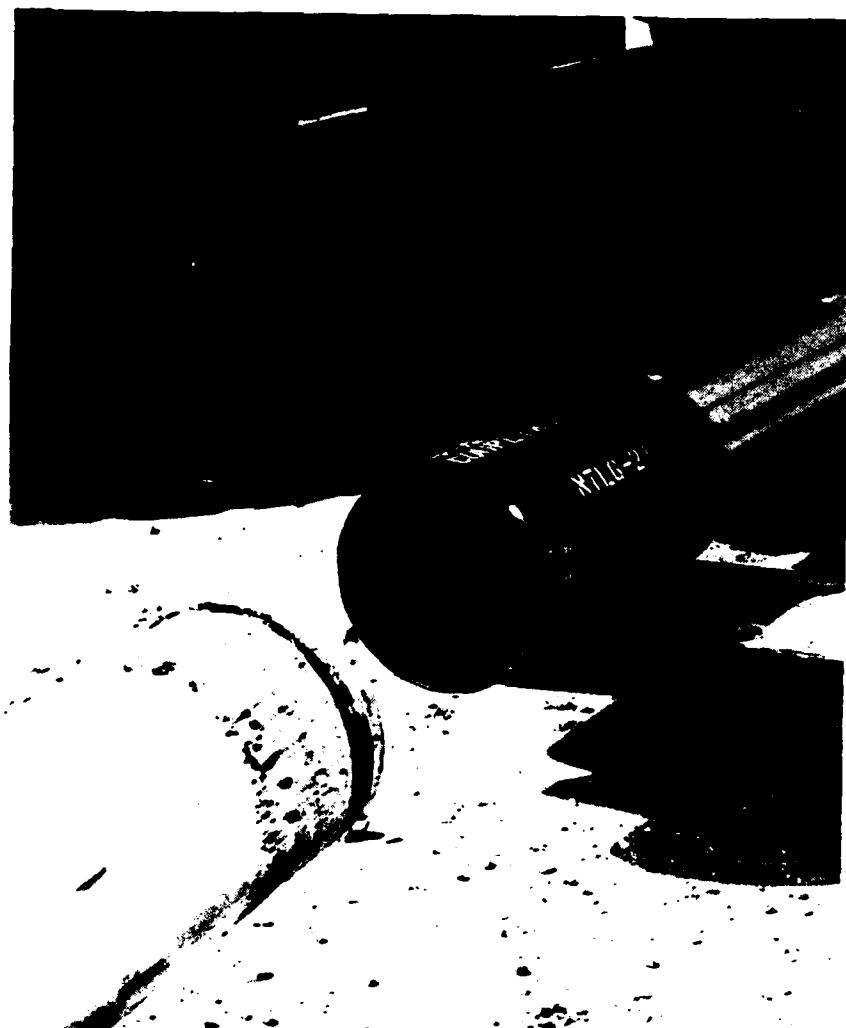
Photo #17: Field tensile test #4. Double-rolled-groove ends pull out at less than 40,000 lb.

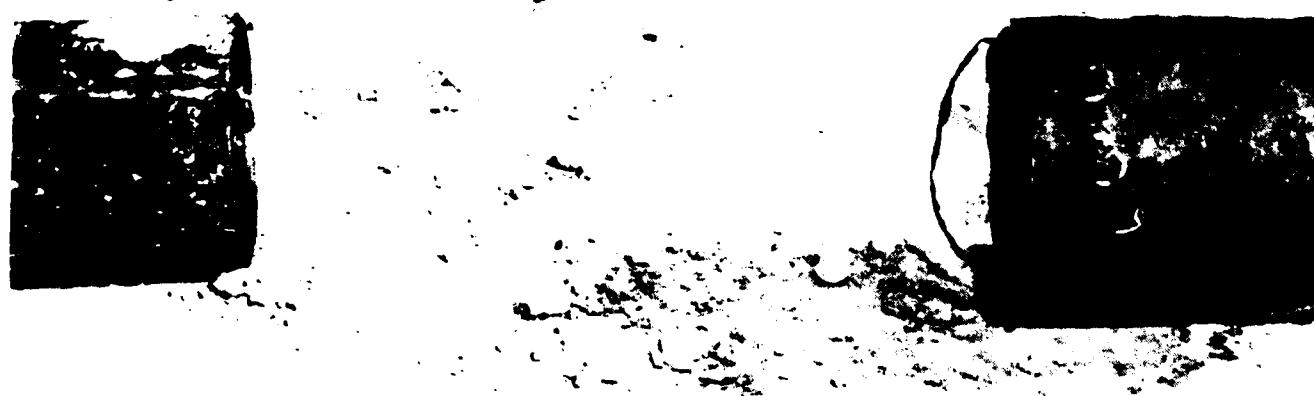
Photo#18: Field tensile test#5. Steel Pipe & Schedule 40 coupling. Sample came apart because of poor insertion.

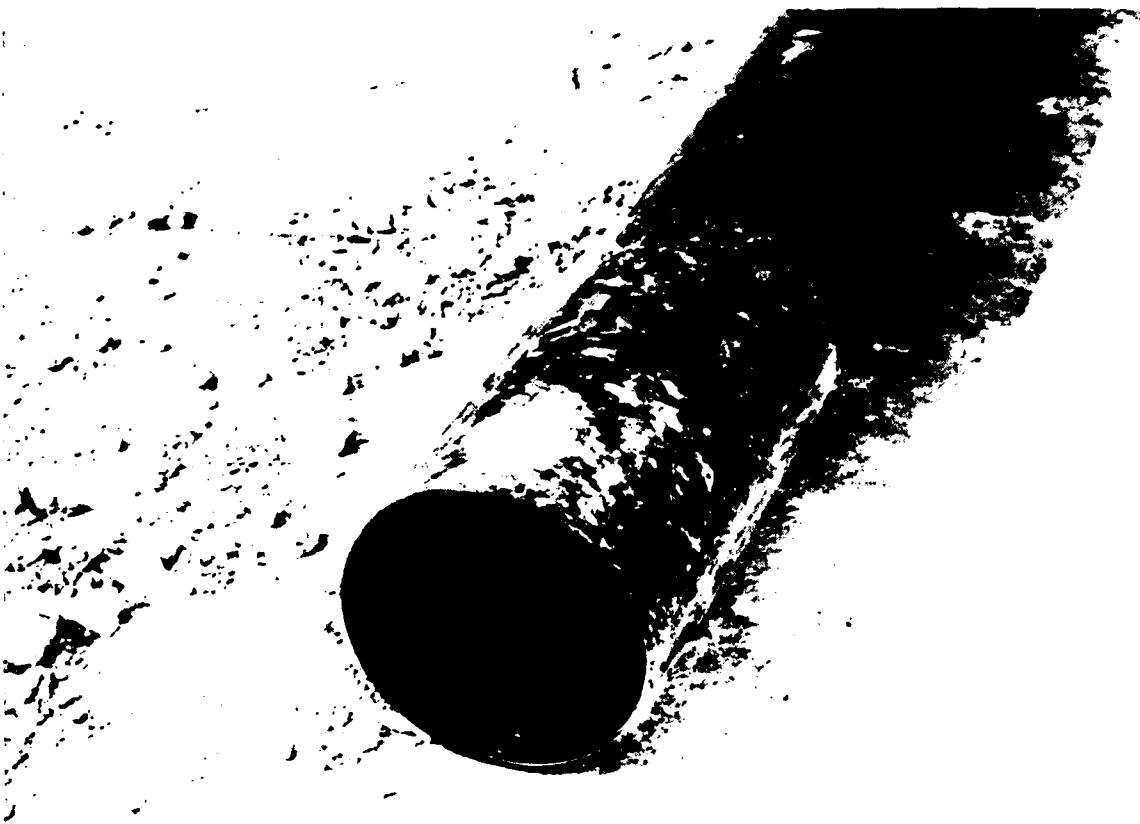
Photo #19: Field tensile test #5. Shows poor insertion depth.

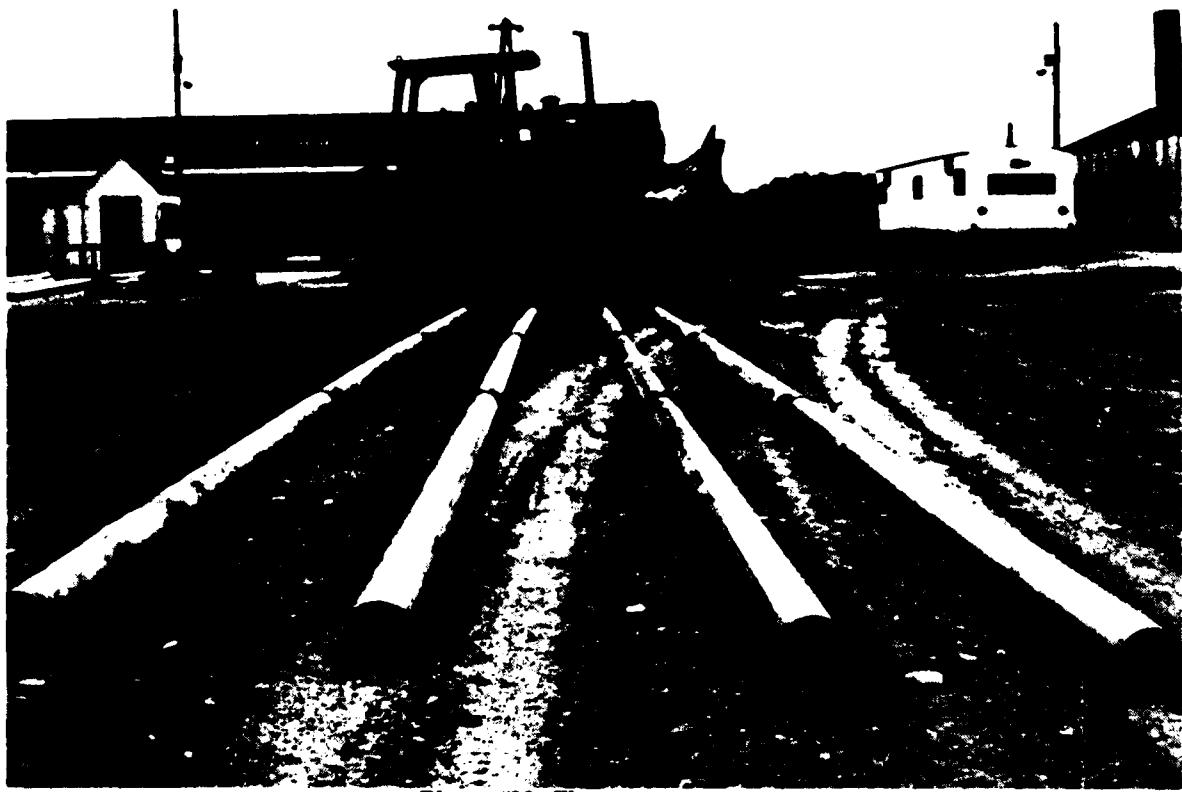
Photo #20: Flexure test setup.

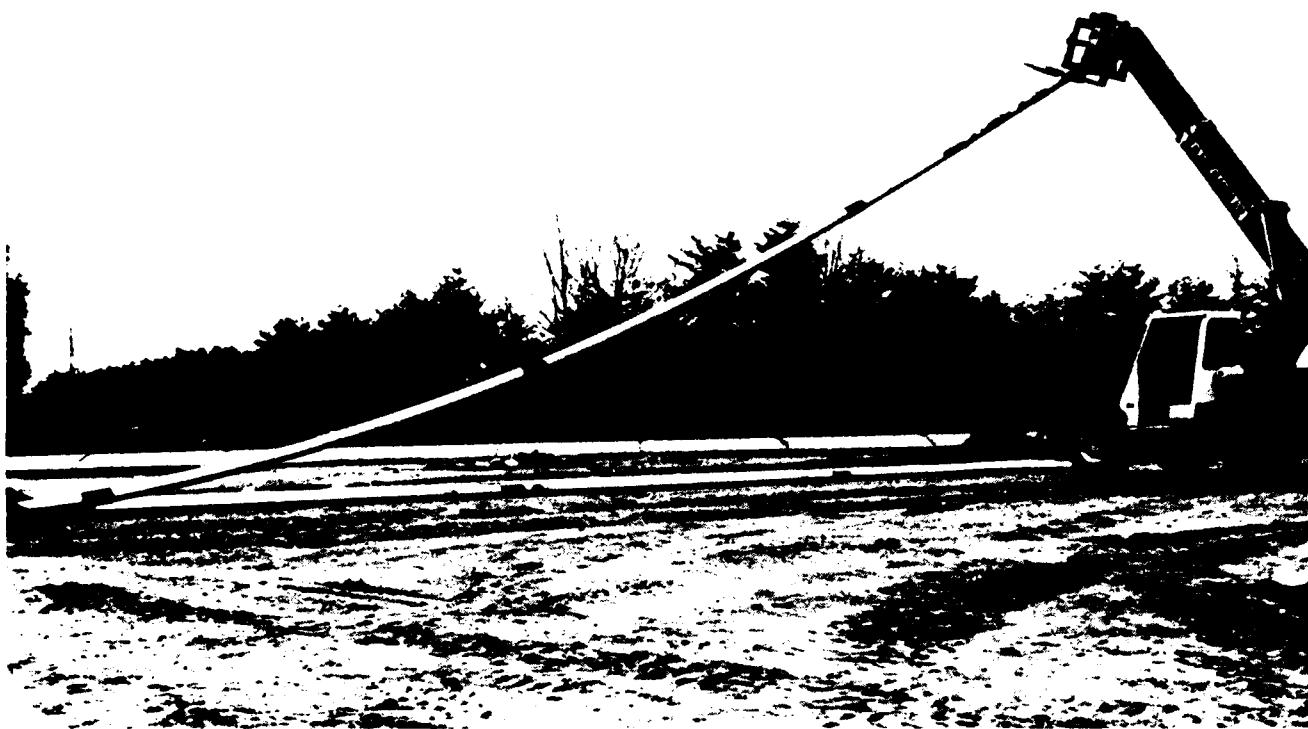
Photo #21: Flexure test #1. The high-reach fork lift could not lift high enough to cause buckling.

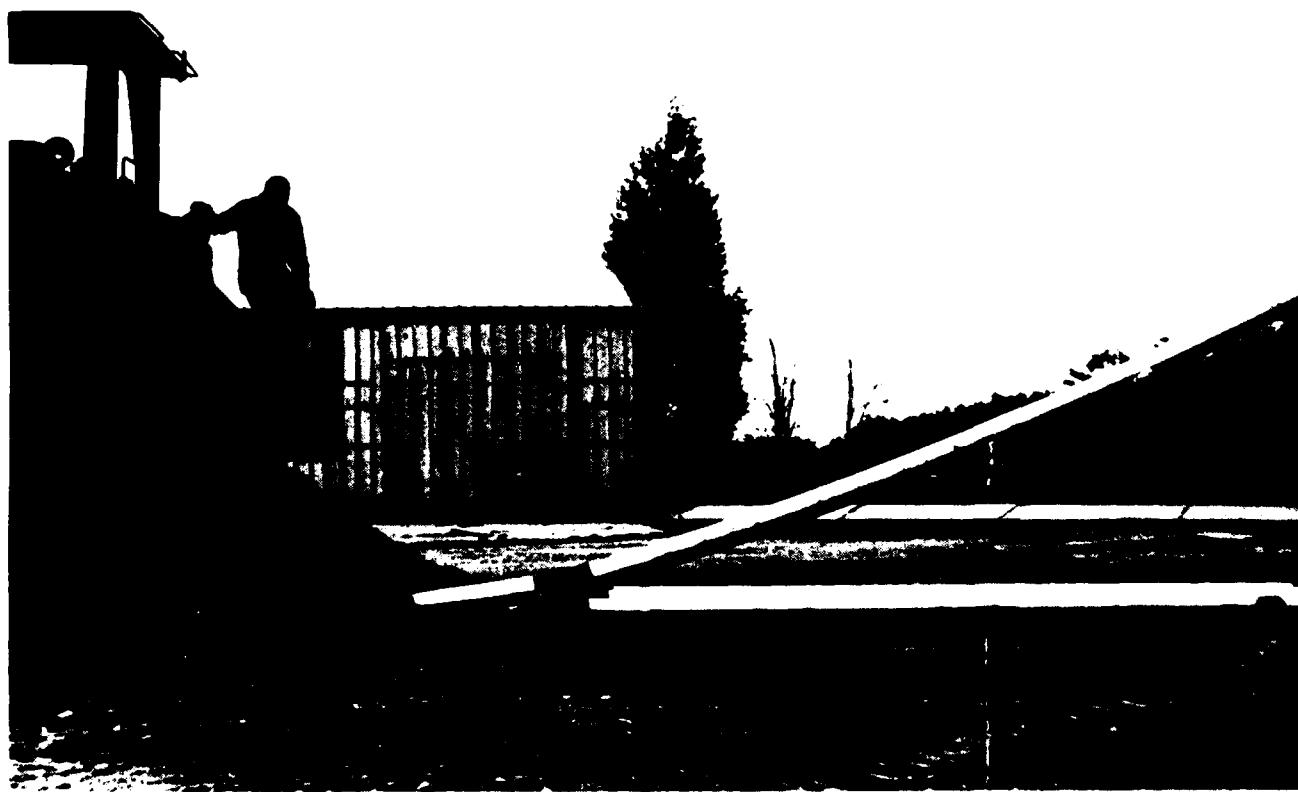
Photo#22: Flexure test #1.

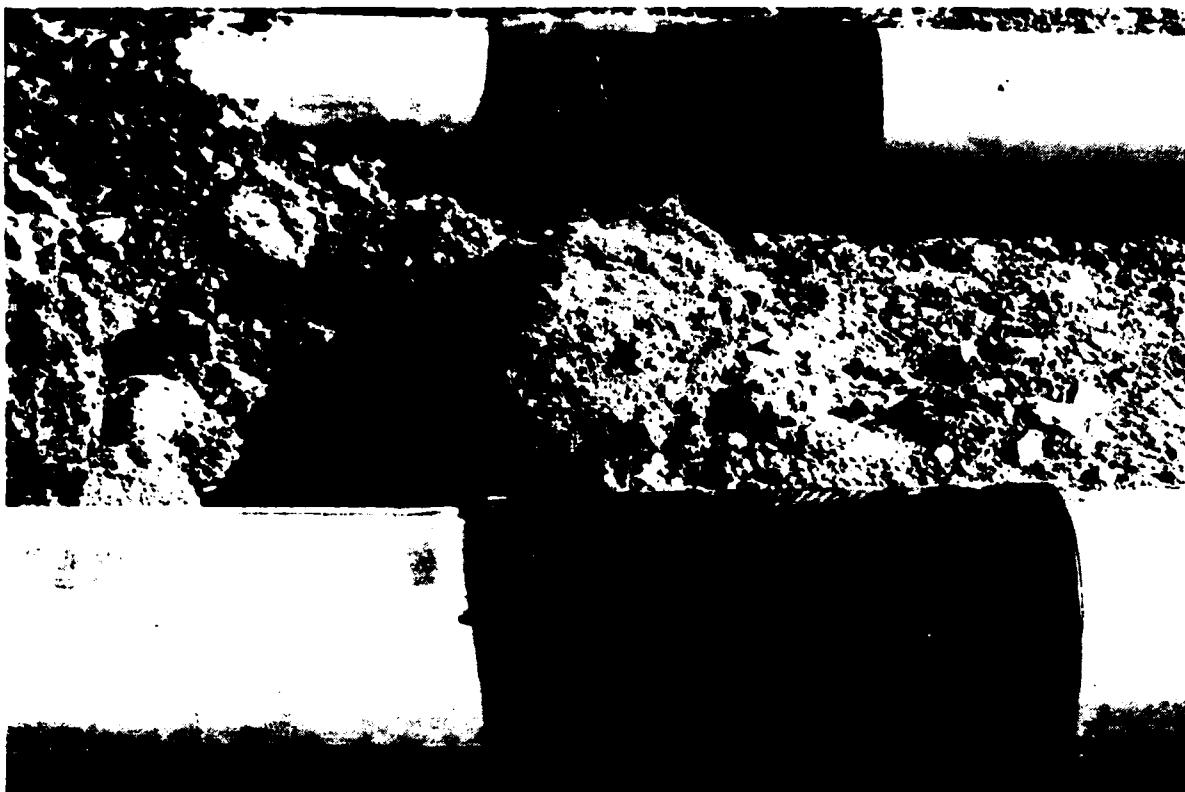
Photo #24: Flexure test #2. after bending moment relieved. Shows deformation.

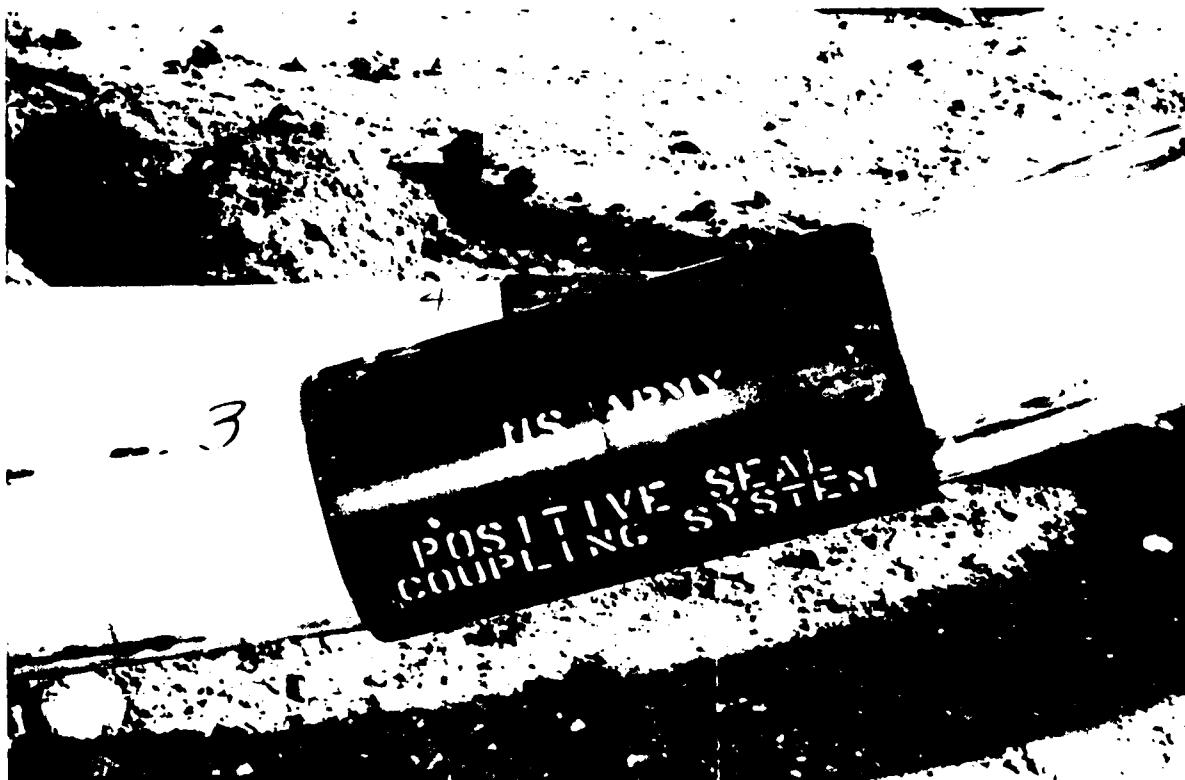
Photo#25: Flexure test #3.

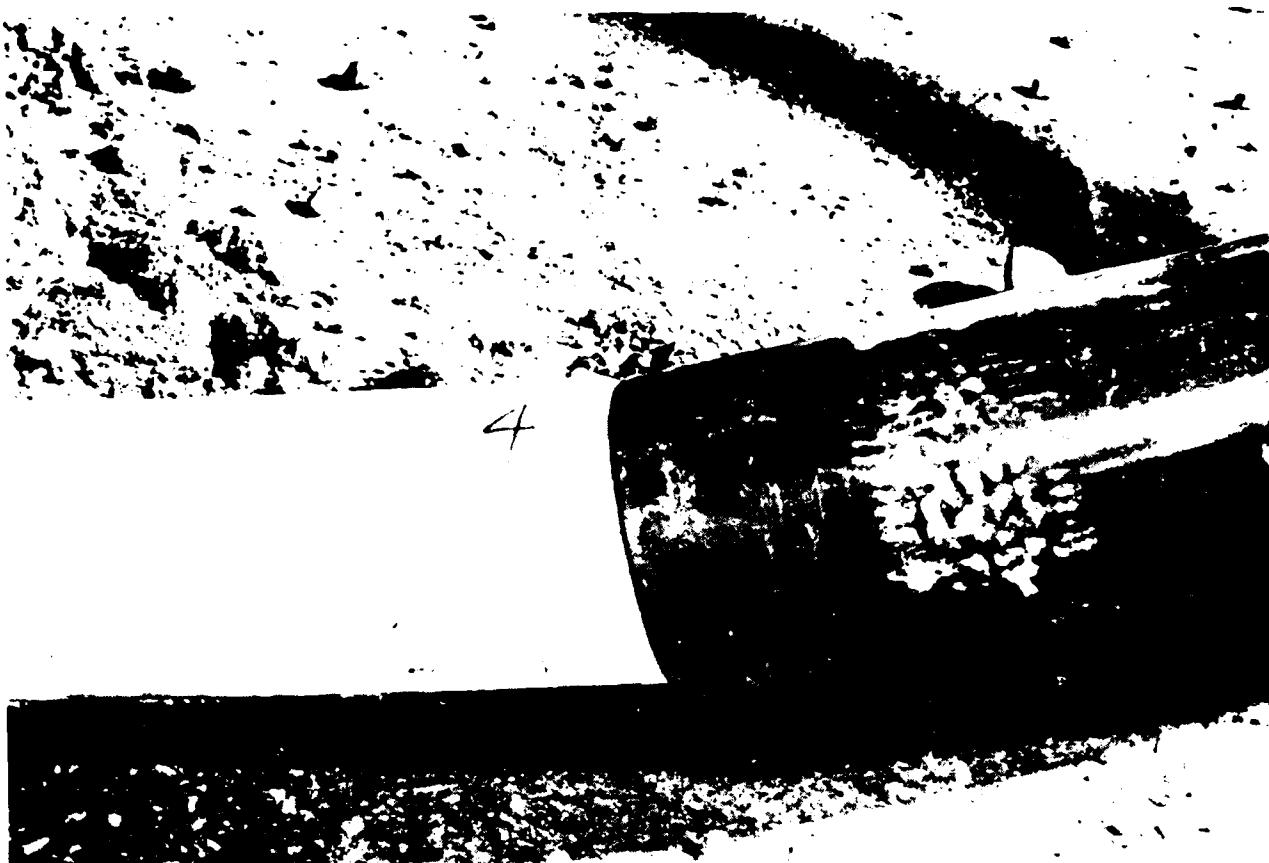
Photo#26: Flexure test #4.
